ARDM-2

(USS ALAMOGORDO)

MOORING INSPECTION REPORT

COOPER RIVER

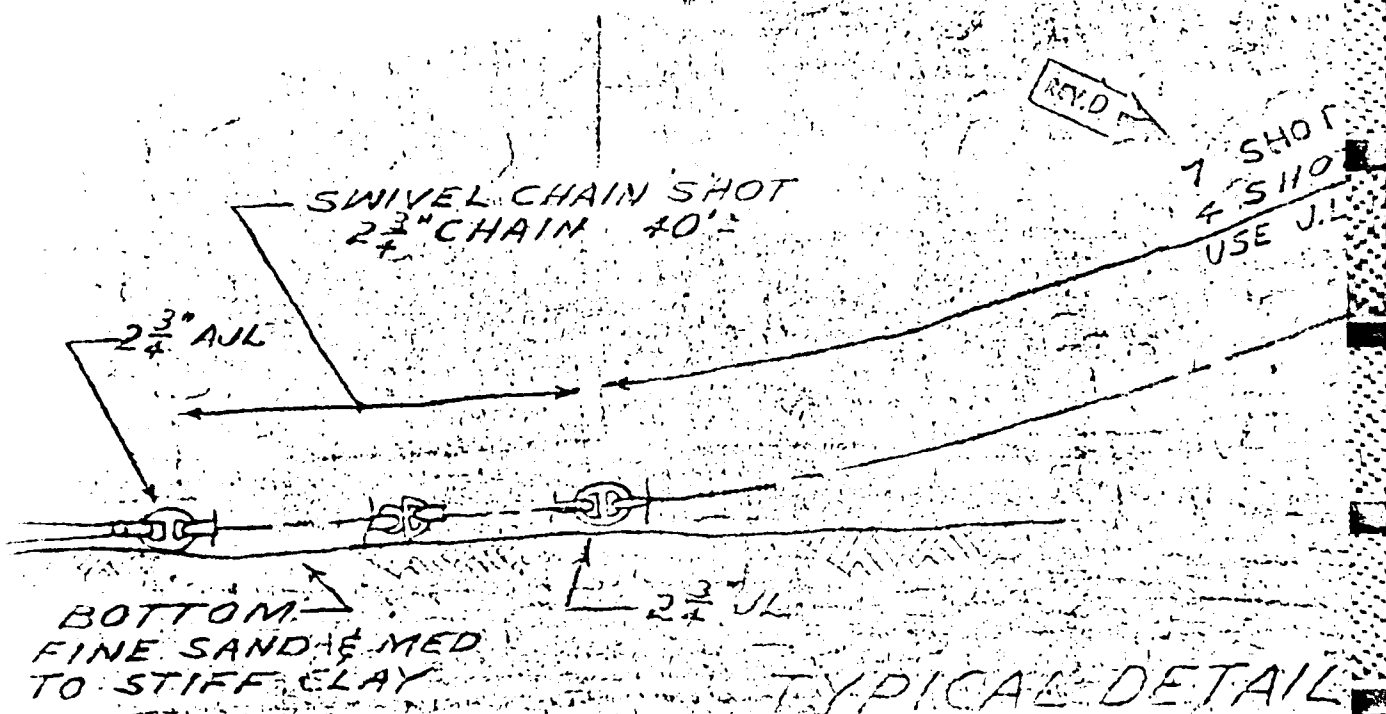
FIGURE 1

The measured chain diameter on the ARDM-2 mooring legs A, B, C, D, H, and M, (see Figure 1) exceed 90% of the original chain diameter and did not require downgrading in capacity. The measured diameter on the ARDM-2 mooring legs E, F, G, and K exceed 80% of the original chain diameter and should be downgraded in capacity to the next largest standard chain size. The ARDM-2 mooring legs I, J, and L were not inspected because auxiliary barges attached to the ARDM-2 presented a possible safety hazard to the divers. These chains should be tentatively downgraded in capacity to the next largest standard chain size.
